HYDROTU & TÜV-SÜD QUALITY CONTROL IN PRODUCTION

YAKINCA 3x4380KW
Hangzhou HYDROTU Engineering

INSPECTION REPORT

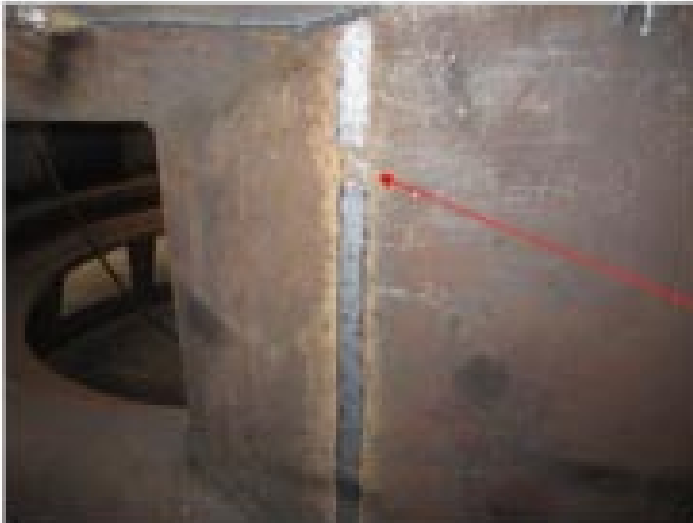
Only one 45° slope-cutting has been fully welded, but grinding is still needed.

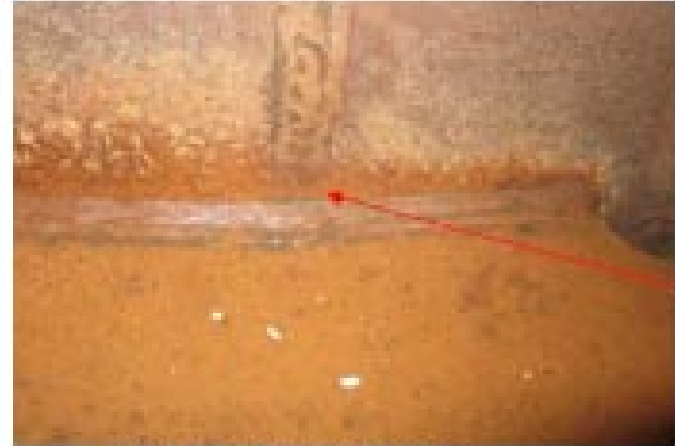
Welding seam is not sufficient.

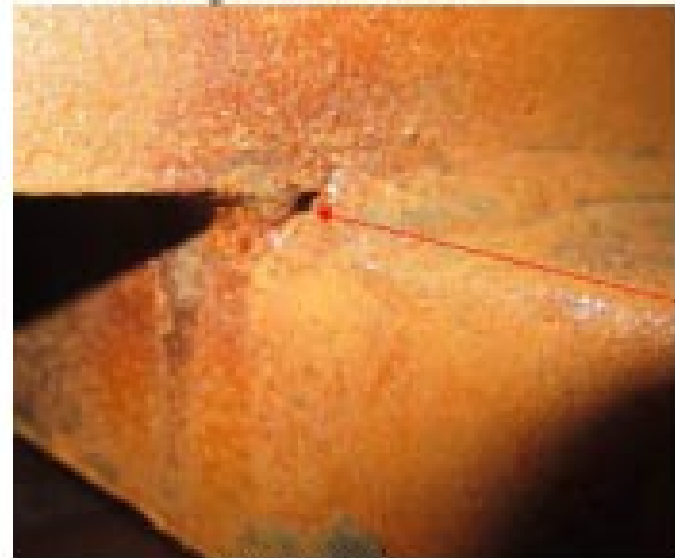
Defected welding

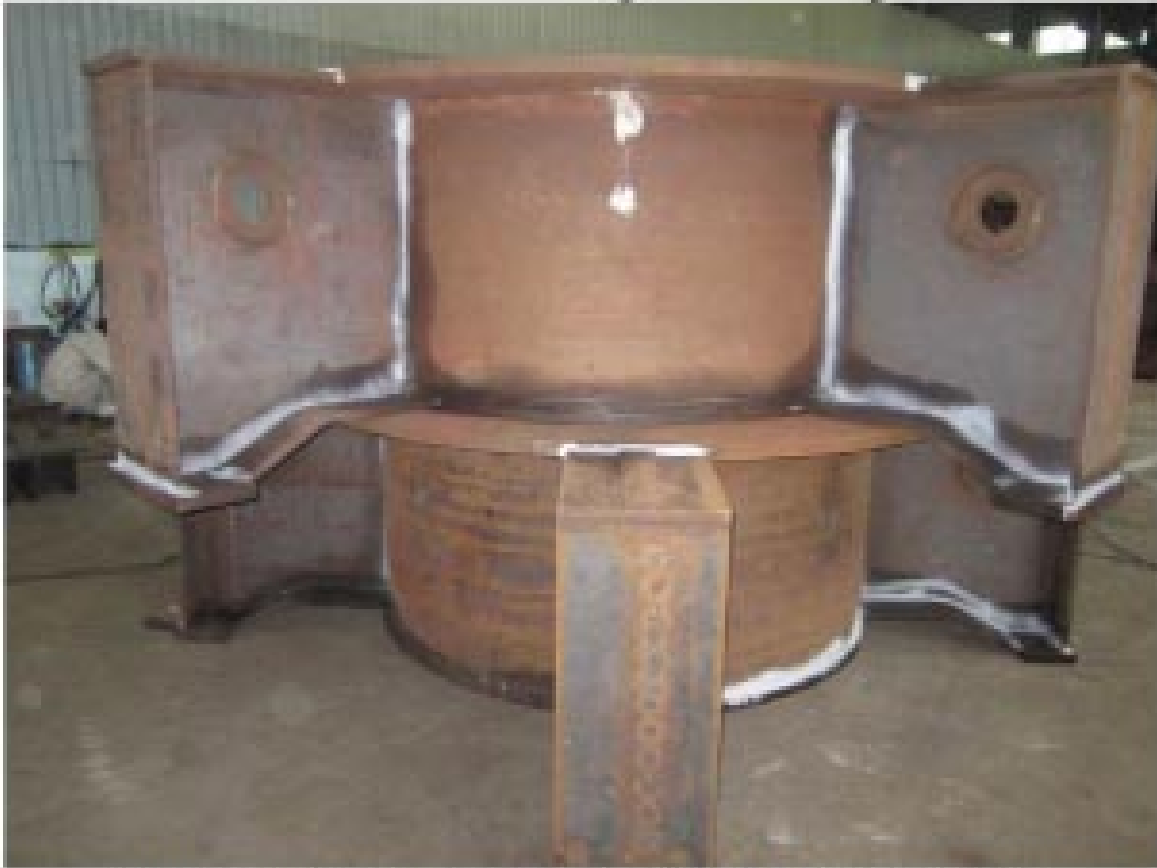
Three upper brackets are annealed. MT is finished.

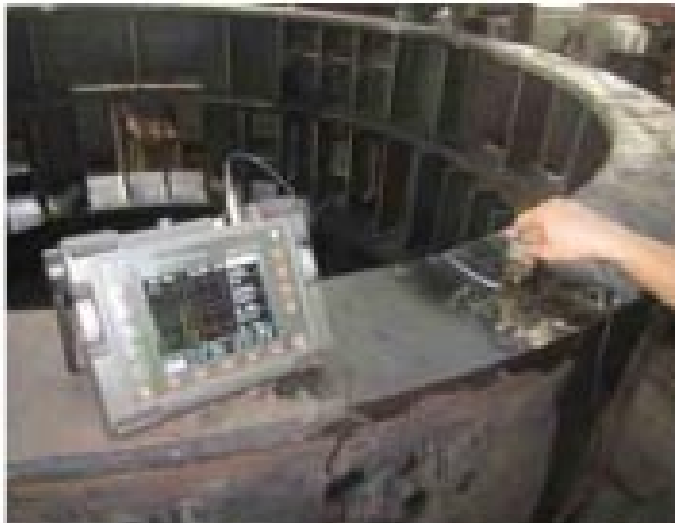
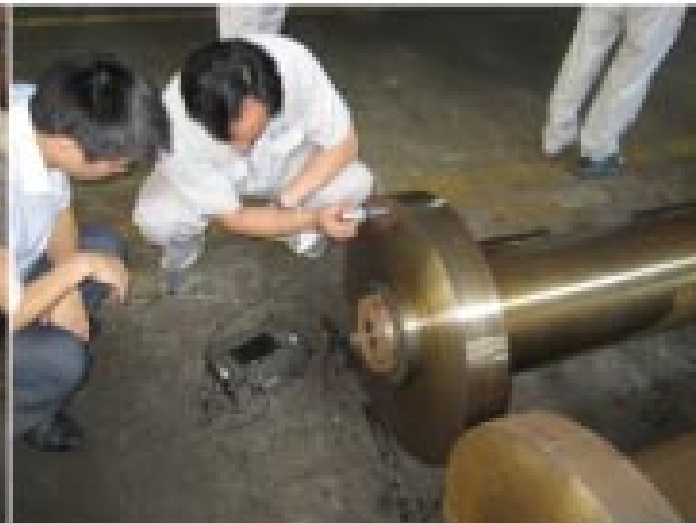
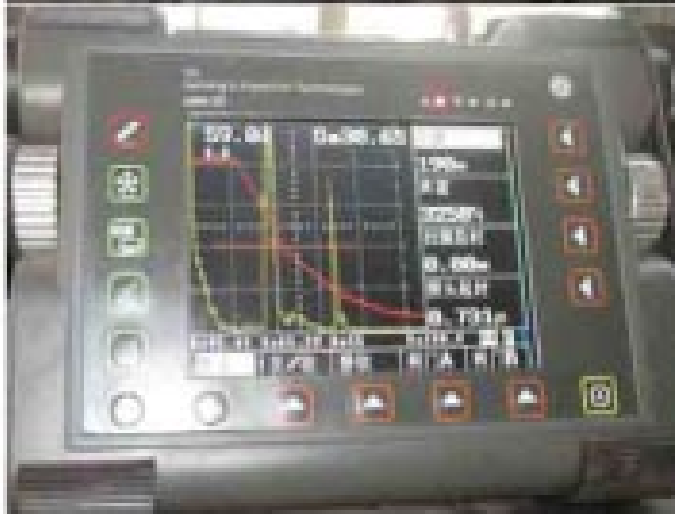
Defect was found

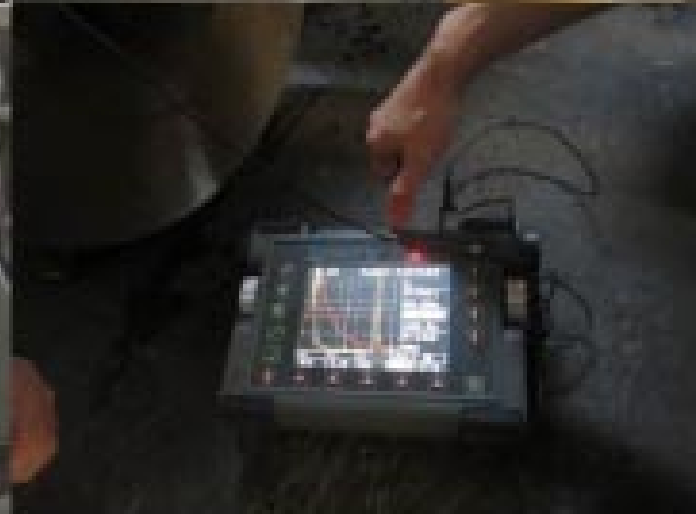
No defect was found

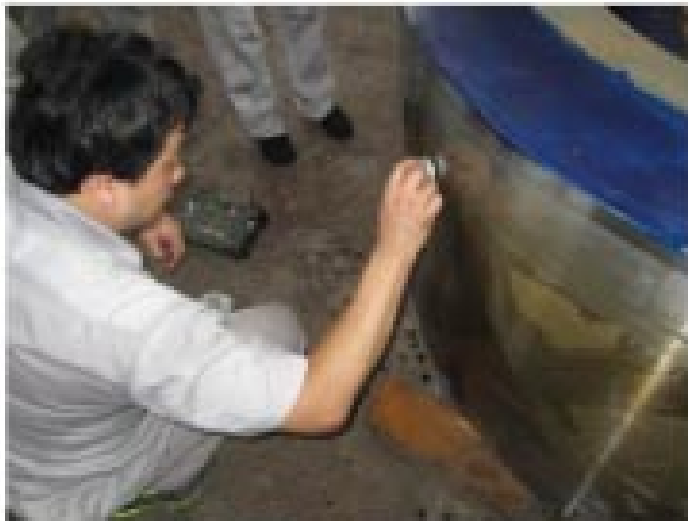
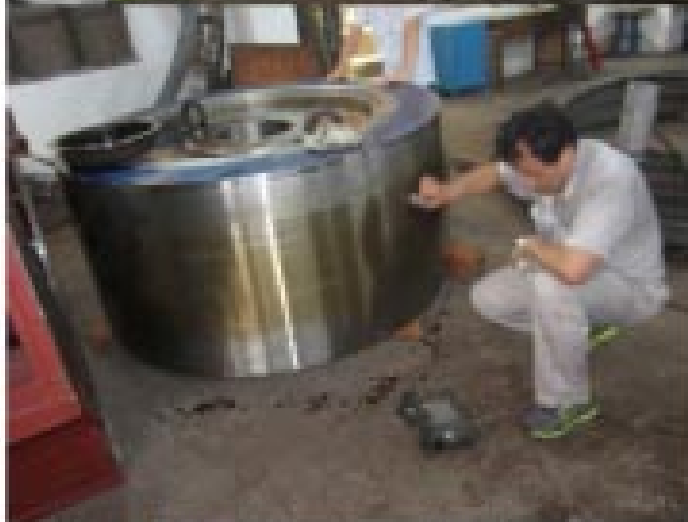
UT testing on end face and around body of a magnetic yoke, the test result is acceptable.
